Attachment 15: Photographs of the Severely Distressed Housing Milwaukee, WI

HOPE VI
Attachment 15
Photographs of Physical Distress

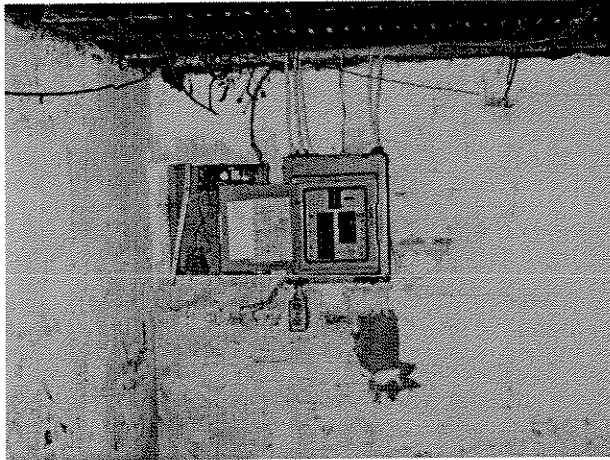
Outdated electrical system.

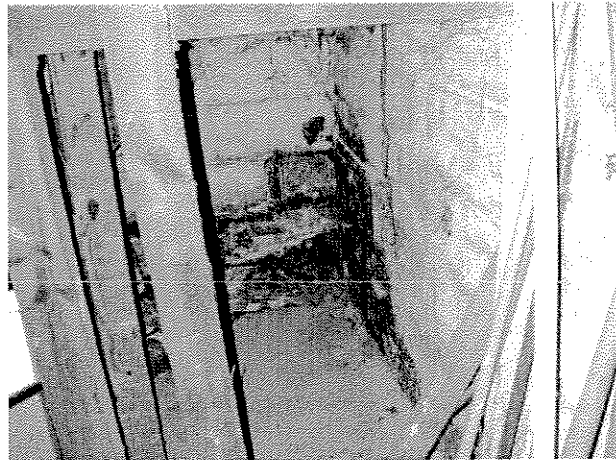
Mold.

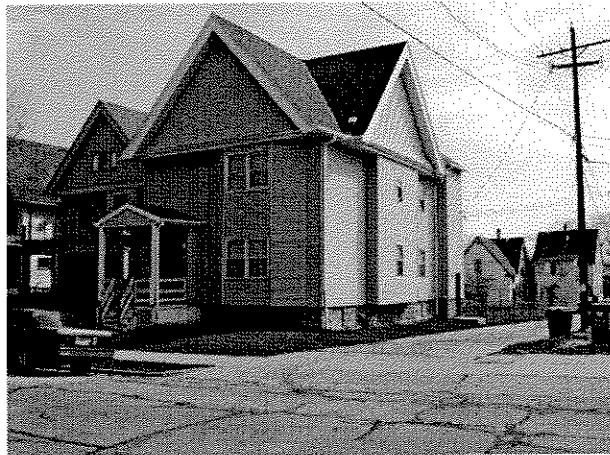
Large inefficient duplex.

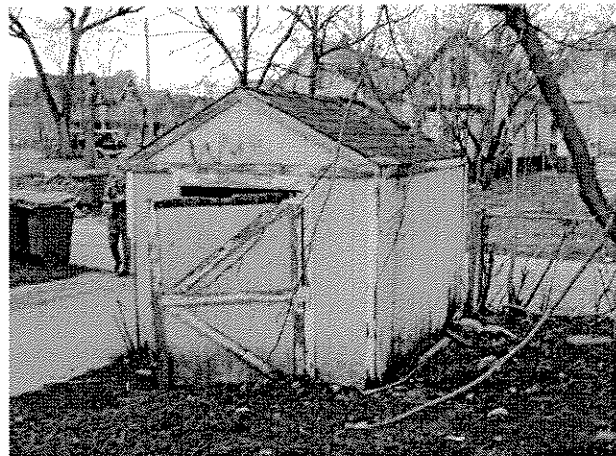
Distressed shed.

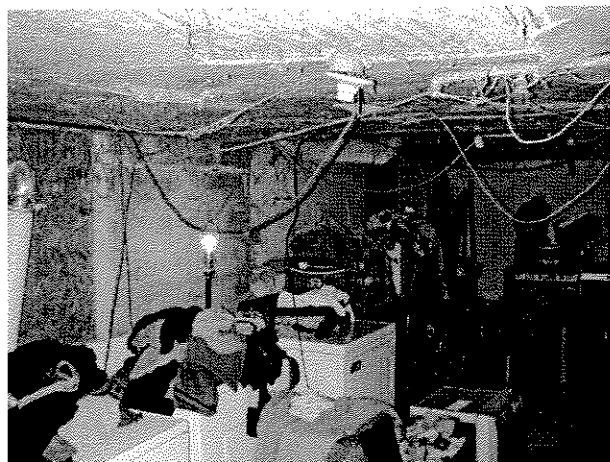
Distressed basement electric, doesn't meet current building standards.

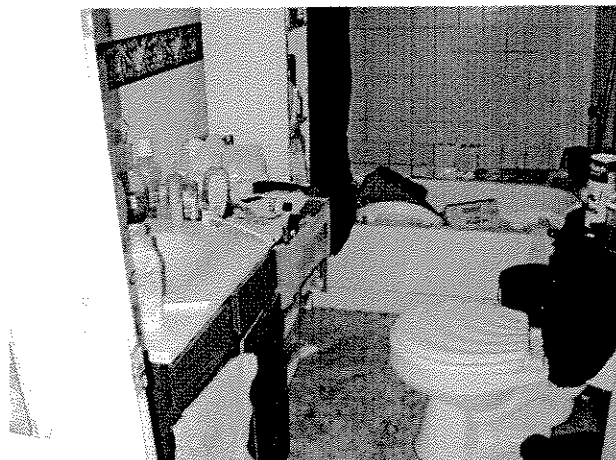
Distressed bathroom. Inaccessible—needs total replacement.

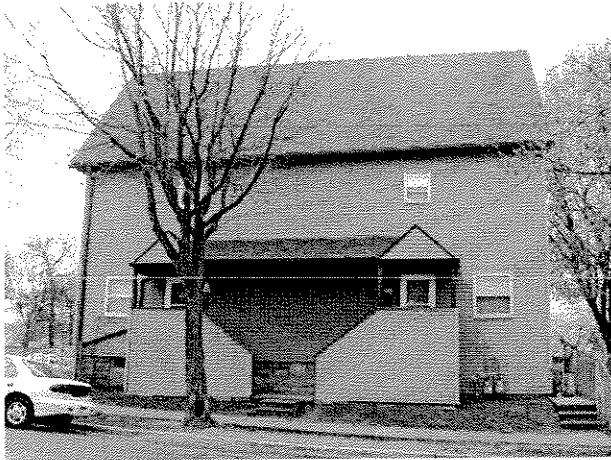
Duplex is not accessible.

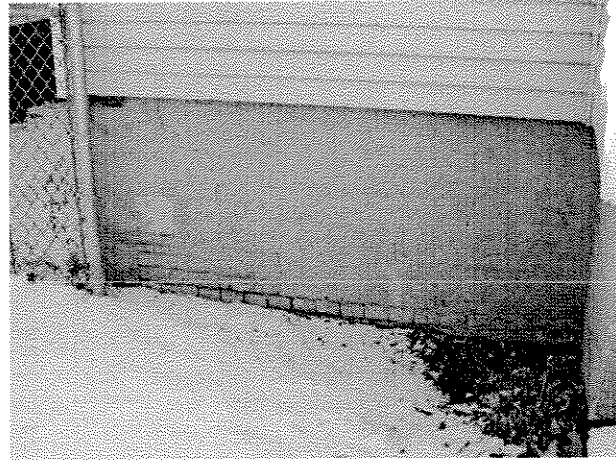
Failing brick foundation.

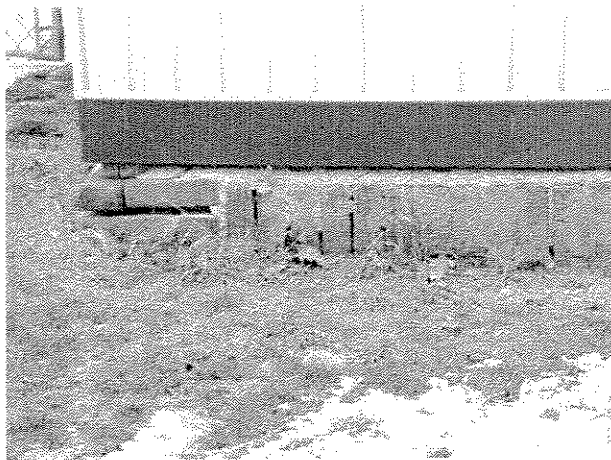
Failing brick foundation.

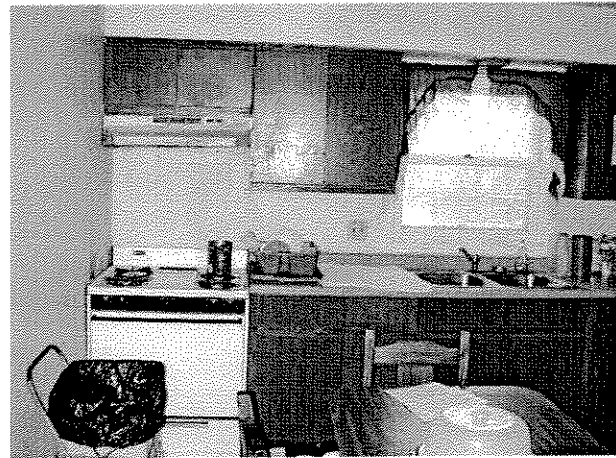
Hazardous kitchen with burn marks on the wall.

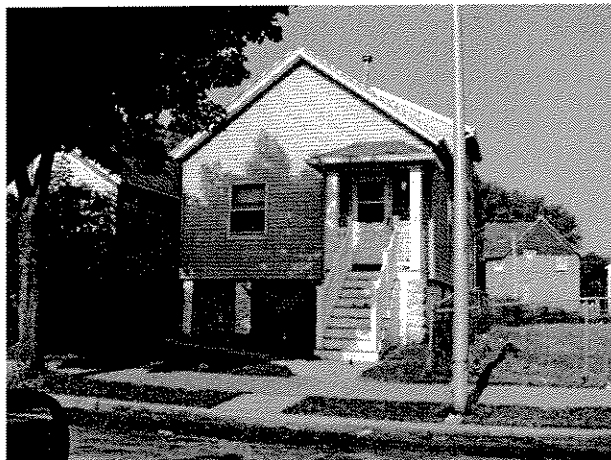
Small house with too many steps (inaccessible).

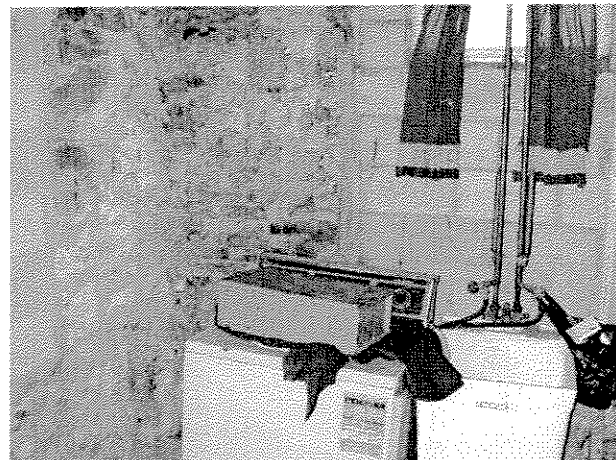
Mixed materials foundation repaired over many years.

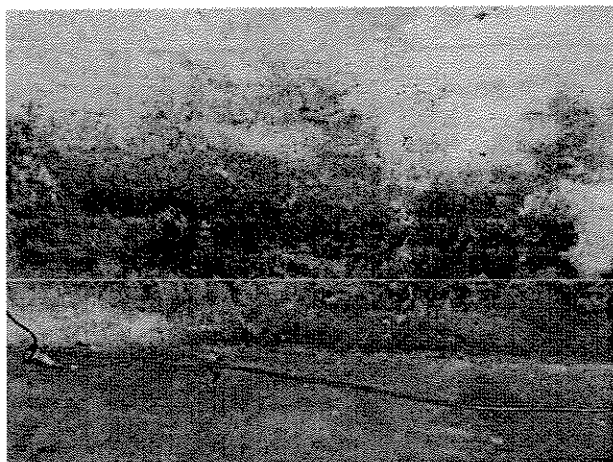
Severe mold on wall.

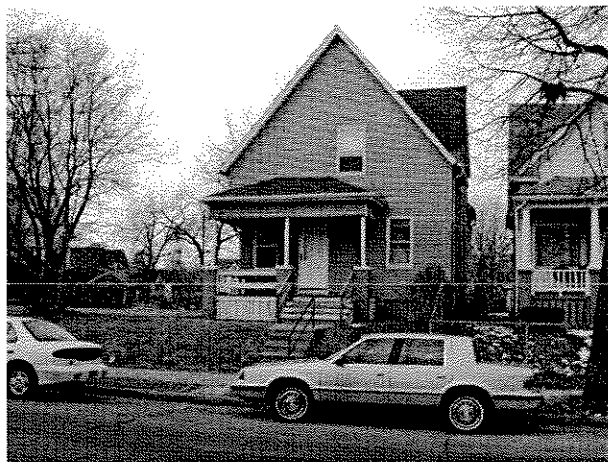
No accessibility.

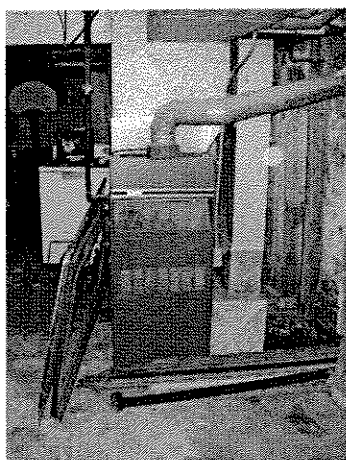
Old inefficient furnace.

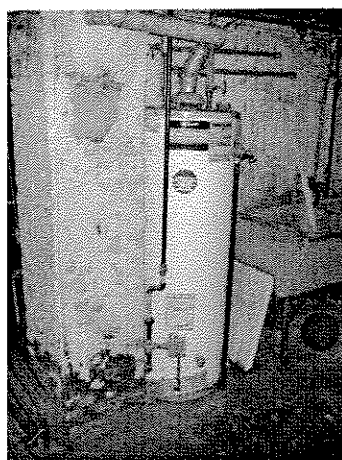
Old inefficient hot water heater.

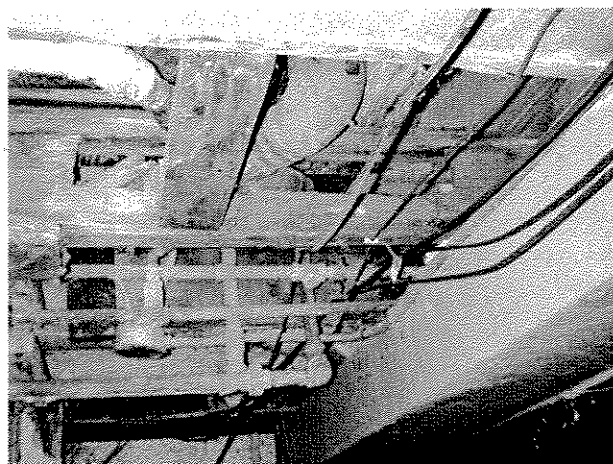
Old plumbing and rotting floors.

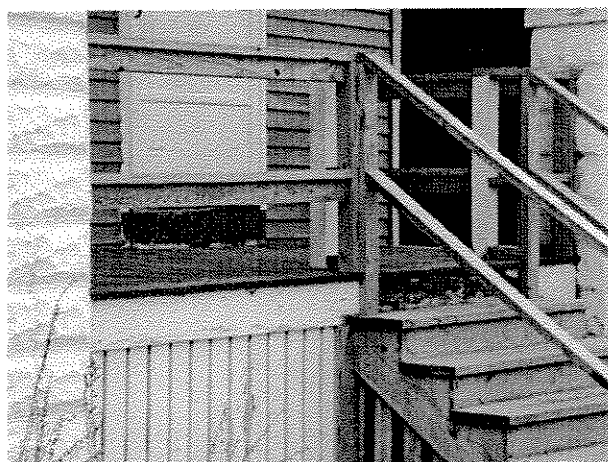
Patched front porch.

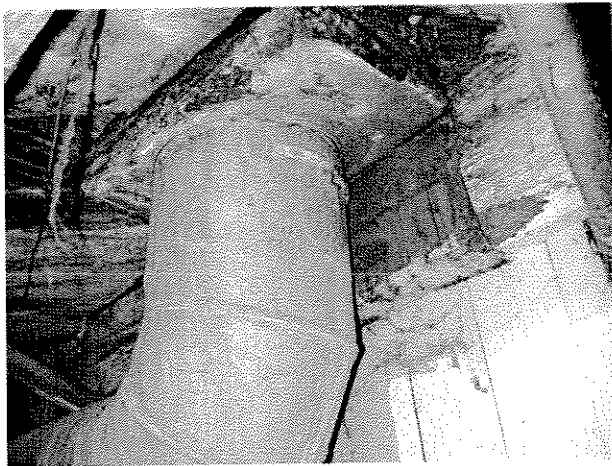
Rusting ductwork.

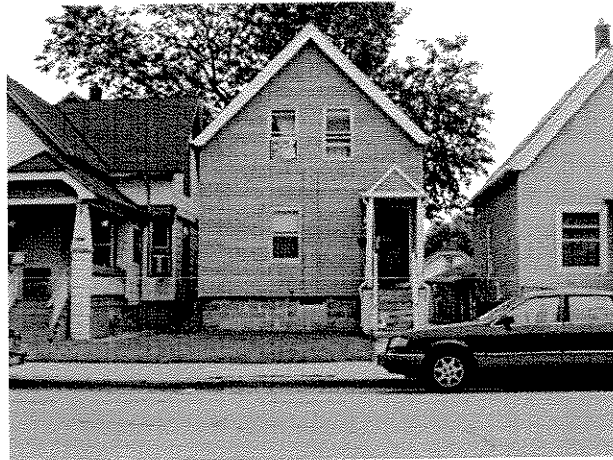
Small house, inaccessible and too dense.

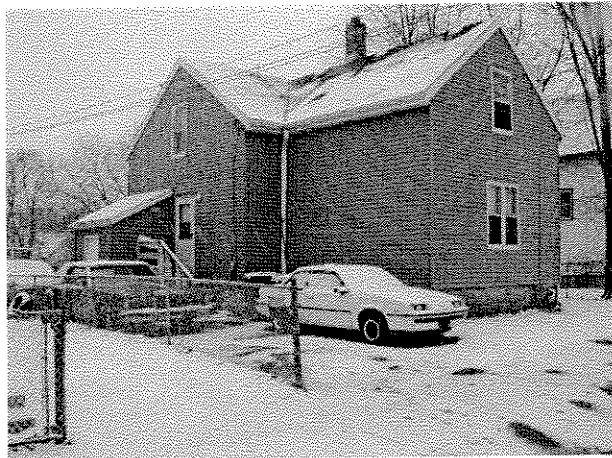
Too many renovations, entrance near back of house.
